# Geosynthetic reinforcement in distressed canal embankment in Gujarat, India : a case study

**Vivek P. Kapadia**

*Water Resources Department, Government of Gujarat, India (vivekpkapadia@gmail.com)*

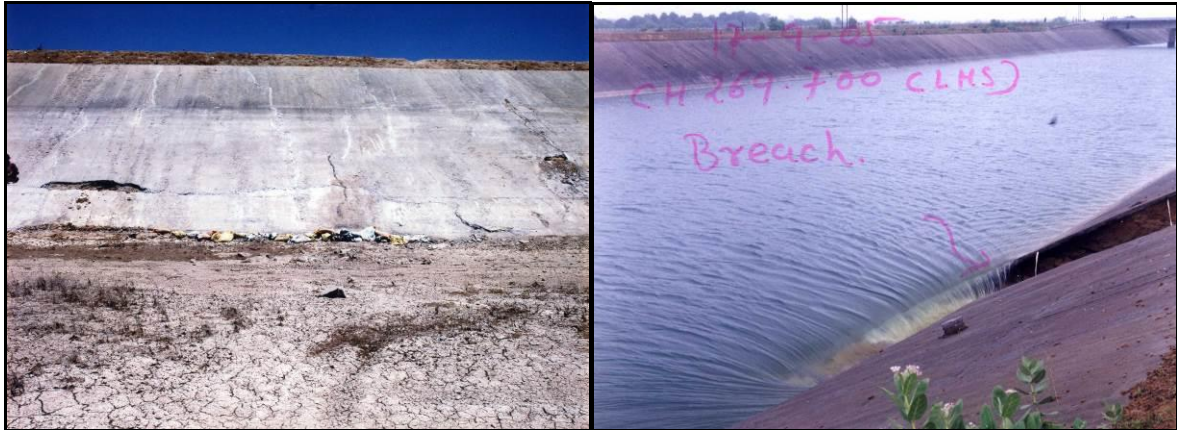
Photograph 1 and Photograph 2. Defects in lining and breach in initial stage

Failure of concrete lining of the canal at a particular height for a noticeable length was also observed as shown in Photograph 1. Snapshot of the very instance of occurrence of the breach in the embankment in September, 2005 is shown in Photograph 2. It clearly shows how piping enlarged to result in to a breach. Devastation in vicinity of the canal is shown in Photograph 3 and Photograph 4. The breach of 11<sup>th</sup> June,

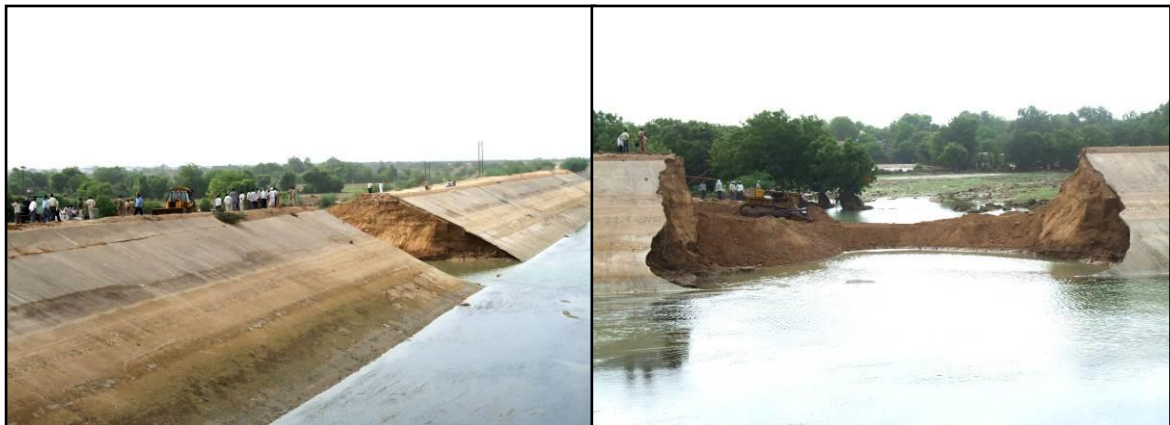
Photo – 5 and 6 Chiselled embankment

2008 was about 65 meter in width and the embankment was found cut in a chiselled fashion as shown in Photograph 5 and Photograph 6.

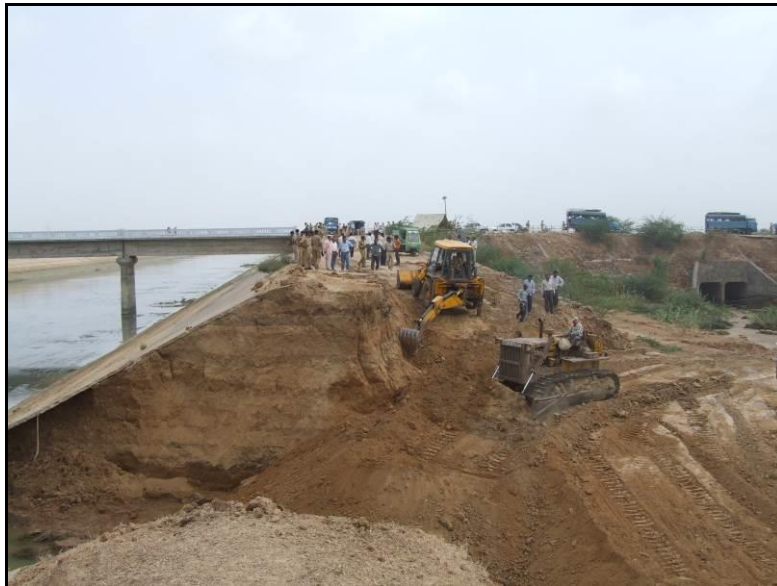
- I. No zones with specific soil properties as per design were actually provided in the embankments.
- II. Obligatory technical specifications for laying and compacting the soils in accordance with their types and properties as well as locations were totally neglected with the result that there were numerous locations and bands of loose or inadequately compacted soil zones.

- III. No chimney filter or horizontal filter blankets were provided to protect the soil and prevent migration of particles outside.
- IV. Due to very loose soil bands, particularly in the lower portion of the embankment, there was substantial subsidence of the earthwork causing loss of support for the plain cement concrete lining. The lining, as a result, cracked irregularly at several places creating even big hollows at some locations. The cracks and openings provided direct entry points for the canal water.

- V. The canal water entering the embankment with relatively high pressure caused dislodgment of particles in the inadequately compacted soil due to high seepage forces resulting into piping and progressive failure ultimately.

Many defects narrated above in construction of canal embankment are clearly viewed in Photograph 7.

Photograph 7. Stratified strata of soil with no zoning or filters
