# DIAGNOSIS AND RESTORATION OF A DISTRESSED DAM: CASE STUDY OF GUJARAT, INDIA\*

Vivek P. Kapadia

Chief Engineer, Narmada, Water Resources, Water Supply and Kalpasar  
Department, Government of Gujarat, INDIA

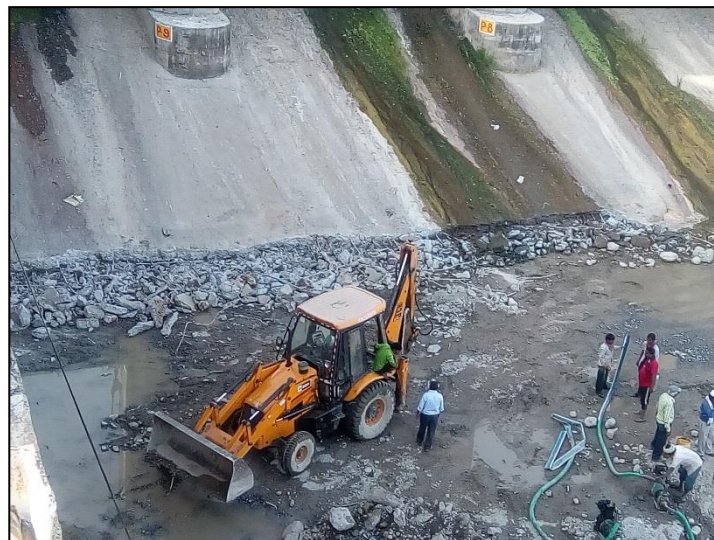
Fig. 1  
Pullout of Reinforcement at Toe

The Gorathiya dam manifested some signs of distress after only 2 years from its completion. Distress in a new dam was a matter of concern. The downstream glacis slope has been 1:3 whose toe got disintegrated and the reinforcements were pulled out as a sign of distress as shown in Fig. 1. The next year the downstream apron got damaged but not in the entire length of the dam, only in the right half of the length i.e. river's half width as shown in Fig. 2.

Disintegration of concrete at toe of the downstream slope of the dam and pulling out of reinforcement in the entire length at the same location clearly suggested that it was not a construction flaw but it was due to cavity formation during release of water. This was because the glacis with 1:3 slope was insufficient to avoid cavity formation. There should have been a much flatter slope or an ogee. This part of the diagnosis was comparatively easy as it required only inspection and some knowledge of design.

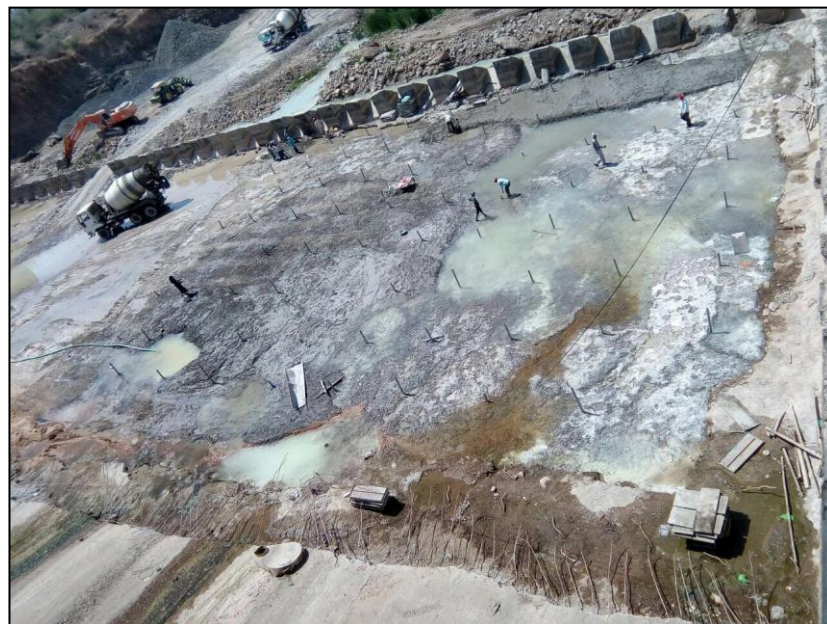
Fig. 2

Top View of Pulled Out Reinforcement at Toe and Damaged Apron

The loose concrete was removed from the apron and fresh concreting was done twice but the same problem recurred. Though the apron was reinforced with thick reinforcements, large pieces of concrete were removed during the operation unlike normal behavior of the apron which exhibits scouring damage after some years.

The reason for repeated damage in the half of the length of the apron was difficult to understand. If it were a design flaw, the damage would have been in the entire length of the dam. If it were a poor quality concrete in the apron, repeated failure could not be there as the repairs were done meticulously. For some years the reason for the said failure could not be identified. To understand the behavior of the apron, the history of site investigation was thoroughly studied to commence with. There was some record that a shallow basalt mine was in operation in the gorge of the river as the river was having good quality basalt in its bed. For preparation of the site, the design included lean concrete filling with large coarse aggregates i.e. plum concrete in the mining pit over which the dam was constructed. The investigation began with identification of width and depth of

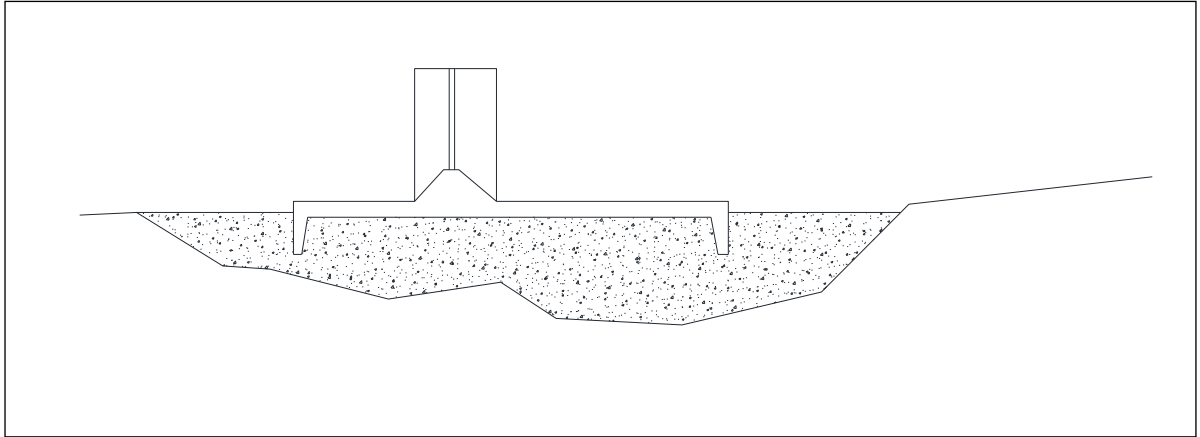
the mine. Some other records with geological mapping suggested that the mine was only in the right half width of the river and the depth was about 9 meter. It was a shallow pit formed by removal of basalt from this location which was advised to be filled up with plum concrete. Location of mine located in right half width of the river and failure pattern of the apron gave a sign of co-relationship. To study the foundation in this context became important to make diagnostic analysis.

Fig. 3  
Schematic Cross Section of Dam and Mining Pit

The apron was removed and the plum concrete beneath was investigated. It was learnt that the large coarse aggregates placed with mechanical locking and no compaction could be done but the cement and sand were in loose form and hence there was substantial amount of water beneath the apron in the voids of the aggregates. The dam was full up to crest level i.e. approximately 6 meter from the bed of the river. The risk of water gushing out from the foundation was also there in the given situation. The scenario on the site gave a clue that the filling of the pit was aimed at plugging it but either the concrete was not allowed to set properly or the compaction was not done properly and hence the concrete had a very loose matrix and hence the voids between the large coarse aggregates were filled up with seepage water from the reservoir in the upstream of the dam. Large coarse aggregates were loosely placed with sand infillings. However, compaction of the concrete was not evidenced. The voids were full of water with a head of about 6 m. There was a clear risk of piping and problem of erosion of plum concrete. The water started flowing out after some hours which corroborated the said finding. This condition was extremely dangerous as at any time the subsurface flow could result in to undermining the foundation and collapse of the concrete dam itself.

The reason for damage to the apron in the right half length of the dam was then understood. When the gates were opened and water was released, the impact of the water fall was supposed to be taken up by the apron which required a solid foundation beneath which actually was not there and hence the concrete apron used to settle which caused sagging resulting in to damage at the bottom and top – bottom damage was not visible but the top was. Thick apron was provided to take the impact but was not designed for large displacement due to

loose subgrade causing bending failure. Every time the gates were operated and the apron was found badly damaged due to this situation.

The objective of filling the pit with plum concrete was to plug the waterway beneath the apron so as to check the hydraulic path beneath the foundation. Keeping in view the same, plum concrete up to 1.5 meter of depth from the bottom of the apron was removed to see the condition of the plum concrete which was tremendously risky but was somehow done by taking necessary precaution. Albeit, a precaution was taken in the form of a temporary plugging of subsurface waterway beneath the toe of the downstream slope. Cement and sand were mixed in 1:4 proportion with high water cement ratio and it was poured up on the loose material so as to allow it to creep inside the dump of aggregates in the pit and plug it. It was allowed to properly set. Then the initial layer of 1.5 meter which was removed was recast with high cement level and polymers so as to ensure a high strength concrete as the foundation. It was a concrete with normal coarse aggregate so as to ensure proper strength and compaction.

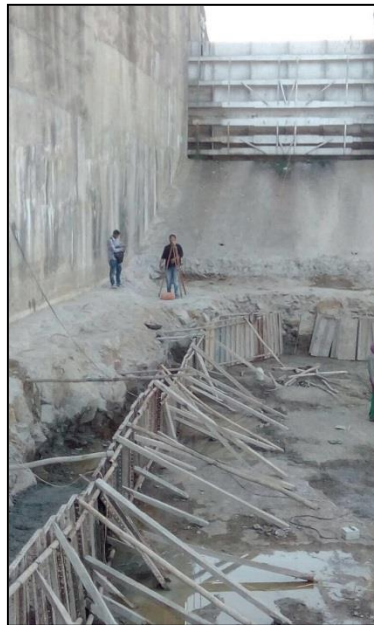
Fig. 4  
Construction of Cut-off under Abutment

The apron was to be recast but it was decided to go for a 5 meter downstream cut-off to ensure checking the hydraulic path from the foundation. Additional cut-off was provided with the new apron. The right side abutment was also found vulnerable and hence the shuttering was made at its foundation after opening it and additional cut-off was also constructed there as shown in Fig. 4. A peripheral cut-off was thus provided as shown in Fig. 5. This was to provide a

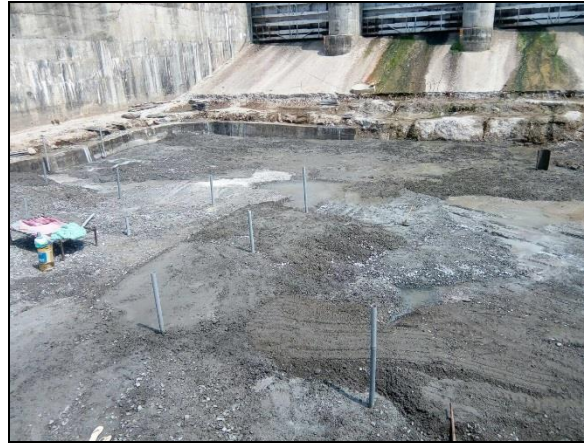
Fig. 5  
Construction of Peripheral Cut-off

confined solid mass to check hydraulic path and uplift. Entire construction activity required constant dewatering. Rapid hardening agents were added to concrete to ensure early setting of the concrete to reduce the construction time as the risk was very high.

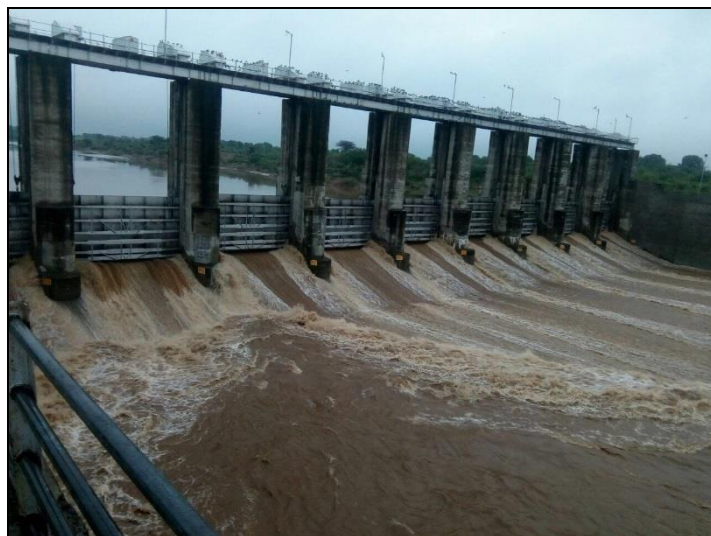
Fig. 6  
Post-Repair Performance of Dam

The solution worked out was tested soon i.e. monsoon 2016 and there was full discharge released from the gates twice as shown in Fig. 6 and it was found that the performance was as per expectations. Again during monsoon of 2017 the release was required. The gates were operated in line with the prescribed gate operation methodology. While the maximum damage was earlier observed during initial flow of 150 cumec, no damage occurred during any discharge – 15 cumec onward up to the designed full discharge after restoration.

Removed portion of concrete apron in half of the length of the dam was provided with horizontal and vertical drainage embedded in to the concrete and the new construction of apron was done with properly compacted polymer concrete with reinforcement mesh at the top. These reinforcements were welded with the protecting reinforcements which were pulled out at the toe of the downstream slope of the dam. The concrete was cast for the apron such that at the toe of the dam was made a curved fillet to avoid pullout during the cavity formation. Strong foundation and strong apron with peripheral key checked the hydraulic path beneath the foundation and also assured impact resistance against the fall of water.
