# APPLICATION OF GEOSYNTHETICS IN RESTORATION OF CANALS : CASE STUDIES OF SARDAR SAROVAR PROJECT

Vivek P. Kapadia, Chief Engineer, Water Resources Department, Government of Gujarat, Gandhinagar - 382010, India

## CASE STUDY – 1 RESTORATION OF BREACHED SECTION OF NARMADA MAIN CANAL

## CASE STUDY – 2 ADDRESSING FAILURE OF CANAL EMBANKMENTS IN SWELLING SOILS

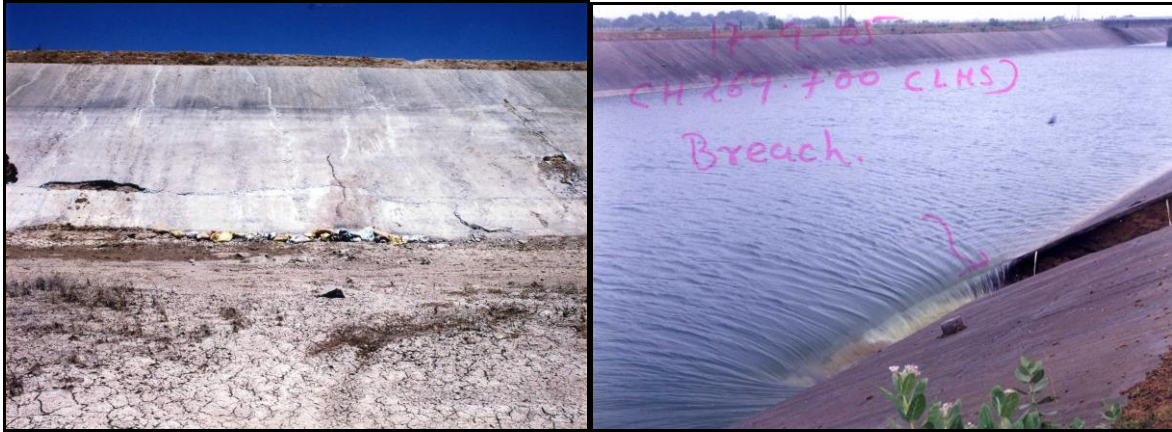
Failure of concrete lining of the canal at a particular height for a noticeable length was also observed as shown in Photograph 1. Snapshot of the very instance of occurrence of the breach in the embankment in September, 2005 is shown in Photograph 2. It clearly shows how piping enlarged to result in to a breach. Devastation in vicinity of the canal is shown in Photograph 3 and Photograph 4. The breach of 11<sup>th</sup> June, 2008 was about 65 meter in width and the embankment was found cut in a chiselled fashion as shown in Photograph 5 and Photograph 6.

Photograph 1 and Photograph 2. Defects in lining and breach in initial stage

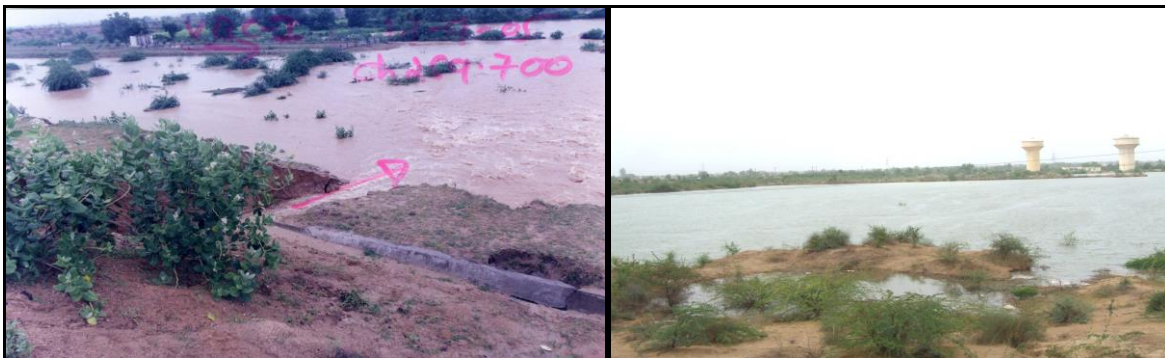
However, on the 11<sup>th</sup> of June, 2008, a breach occurred in the canal near Kadi at Ch. 272.6 km inundating nearby villages and disrupting the water supply to the downstream area. Prior to that from 2005 i.e. soon after completion of the construction of the canal in this reach breaches had started taking place and many piping locations had been observed which are summarized in Table 1.

Photograph 3 and Photograph 4. Devastation in vicinity of the canal

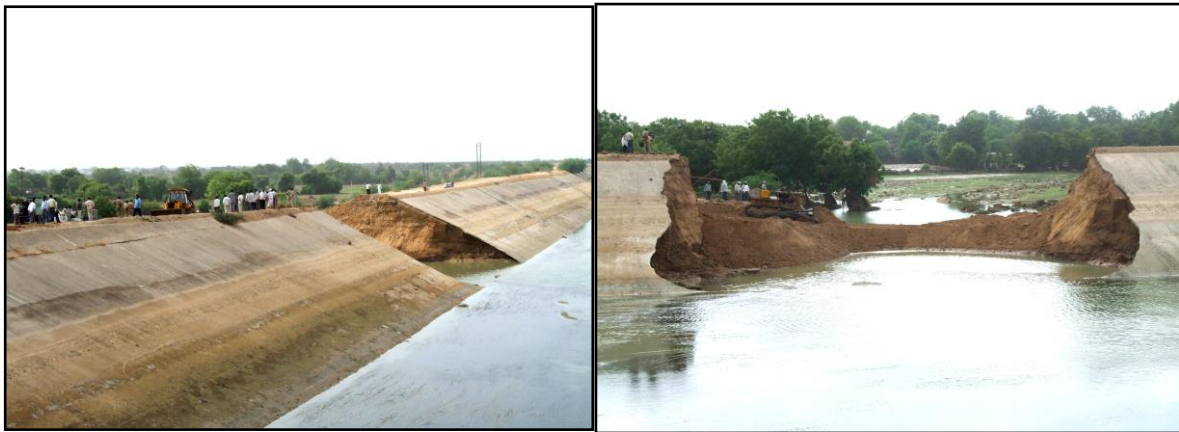
Photo – 5 and 6 Chiselled embankment

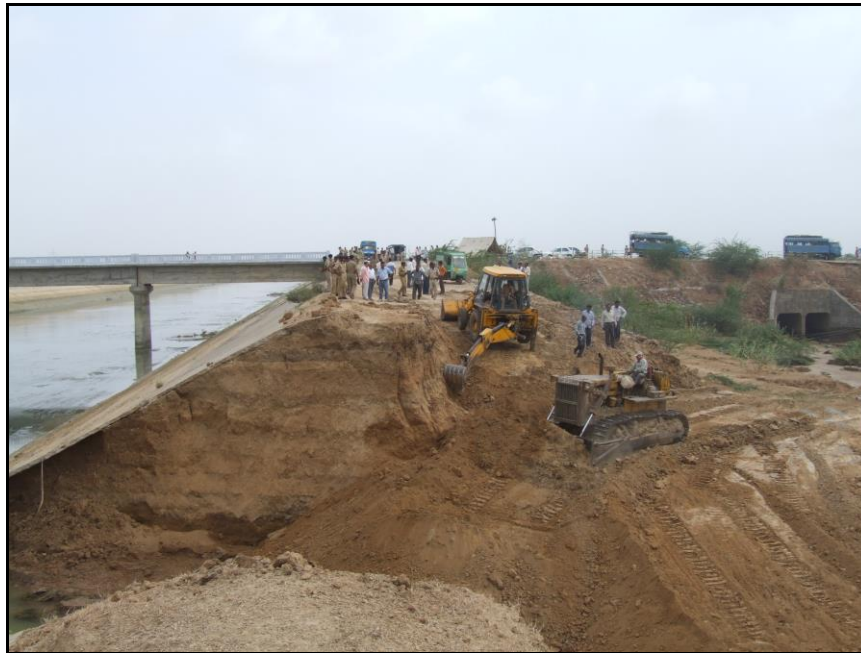
Detailed investigation led to the conclusion that the soils in this reach are predominantly silty sands and clayey sands. There are some clayey strata also but generally less prevalent. The silty sands tend to be more uniform in grain size and have less cohesion with less resistance to erodability. According to the standard soil classification the soils can be classified as SM, SM-ML, ML, CL and CI. The clay horizons show clays of low to medium plasticity (CL and CI) and occasionally high plasticity (CH). These soils, if properly utilized in the construction of the embankment in appropriate zones with strict adherence to the specifications for the moisture content, laying and compaction would not pose any problem for the stability of a properly designed embankment incorporating necessary protective filters and toe protection. However, the actual state of canal bank as per investigation was constructed with some serious defects given below.

- I. No zones with specific soil properties as per design were actually provided in the embankments.

- II. Obligatory technical specifications for laying and compacting the soils in accordance with their types and properties as well as locations were totally neglected with the result that there were numerous locations and bands of loose or inadequately compacted soil zones.

- III. No chimney filter or horizontal filter blankets were provided to protect the soil and prevent migration of particles outside.
- IV. Due to very loose soil bands, particularly in the lower portion of the embankment, there was substantial subsidence of the earthwork causing loss of support for the plain cement concrete lining. The lining, as a result, cracked irregularly at several places creating even big hollows at some locations. The cracks and openings provided direct entry points for the canal water.

- V. The canal water entering the embankment with relatively high pressure caused dislodgment of particles in the inadequately compacted soil due to high seepage forces resulting into piping and progressive failure ultimately.

Many defects narrated above in construction of canal embankment are clearly seen from Photograph 7.

Photograph 7. Stratified strata of soil with no zoning or filters

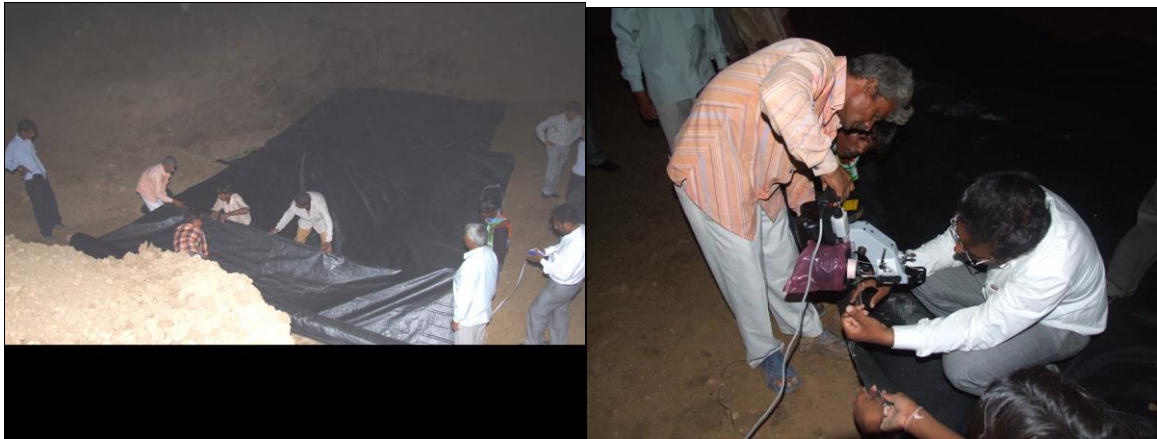
Photograph 8 and 9. Spreading, stitching and placing geosynthetic sheet

Finite Element Analysis was also done in addition to the conventional design procedure<sup>2</sup> to ensure the safety of the embankment. Implementation is shown in Photograph 8 and Photograph 9. Completed work is shown in Photograph 10 and Photograph 11. To accommodate adjustments within embankment due to probability of lack of proper compaction, Reinforced Concrete lining was done in 80 meter length of the canal so that flexibility is added to concrete.

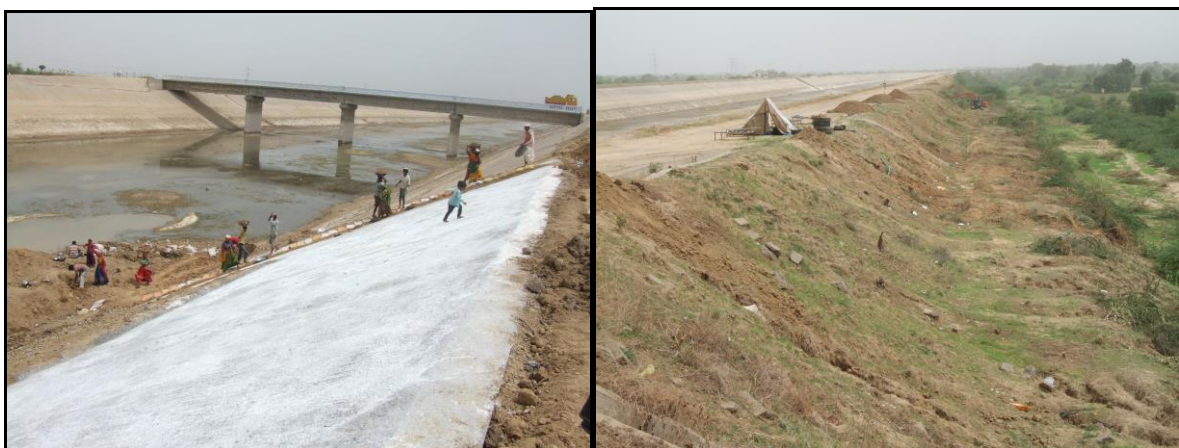
Photograph 10 and 11. Restored Main Canal embankment

Implementation was done in only 10 days and canal flow was allowed. Regular observation was made for a considerable time thereafter and it was observed that the performance of the embankment was well.

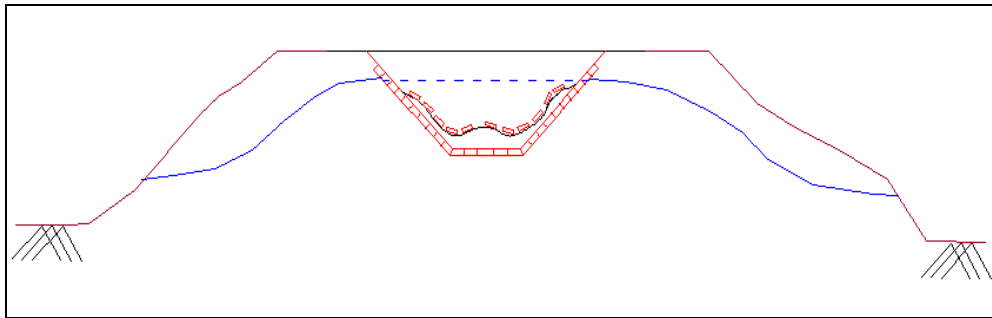
Figure 6. Disturbed profile of canal due to swelling of embankment soil

During January 2010, the engineers of the SSNNL surveyed “Tanchha Distributary”. This distributary passes by close to the village of “Anor” of Amod Taluka. It was observed that it was leaking very heavily and the agricultural fields in the surrounding areas were found to get inundated with water. This situation has been occurring for the last three years. The overall condition of the canal was very bad; the bed of the canal was highly uneven; the brick lining was significantly disturbed. This is schematically shown in Figure 6.

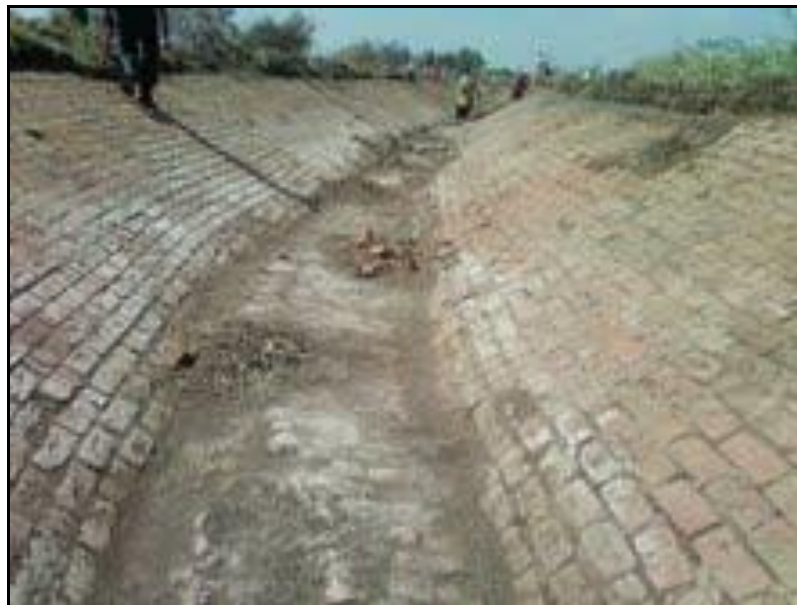
The deteriorated condition of the canal was visible. The bed of the canal was also unusually swollen as shown in Photograph 12. There were several other issues. The banks were disbursed and scattered.

Photograph 12. Swelling of bed and sides of canal

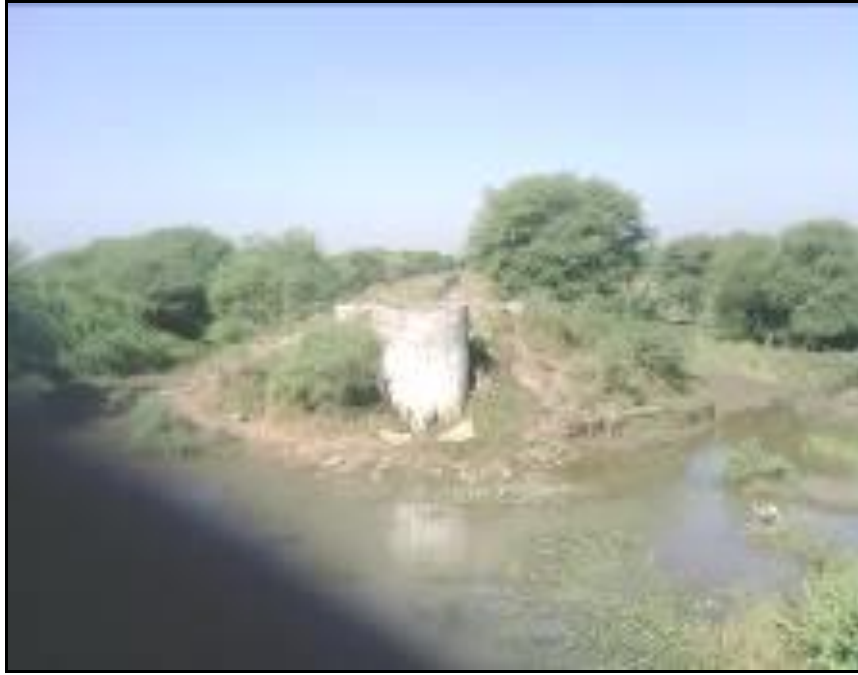
Photograph 13. Leakage from canal

The canal section at one location was found to be much wider in comparison to what it was originally. The embankments had also been dislocated. At several locations, cracks and breaches were patched up by cement mortar or through plastering to restrict water seepage. The local farmers were forced to construct bunds on either sides of the canal to patch up the failure of the embankment. However, this solution was not satisfactory because of the propensity of the canal embankment to break repeatedly and suddenly.

Piping from canal banks i.e. sides of the canal and leakage from canal siphons both contributed to the seepage. These occurrences used to result in water inundation of the surrounding areas.

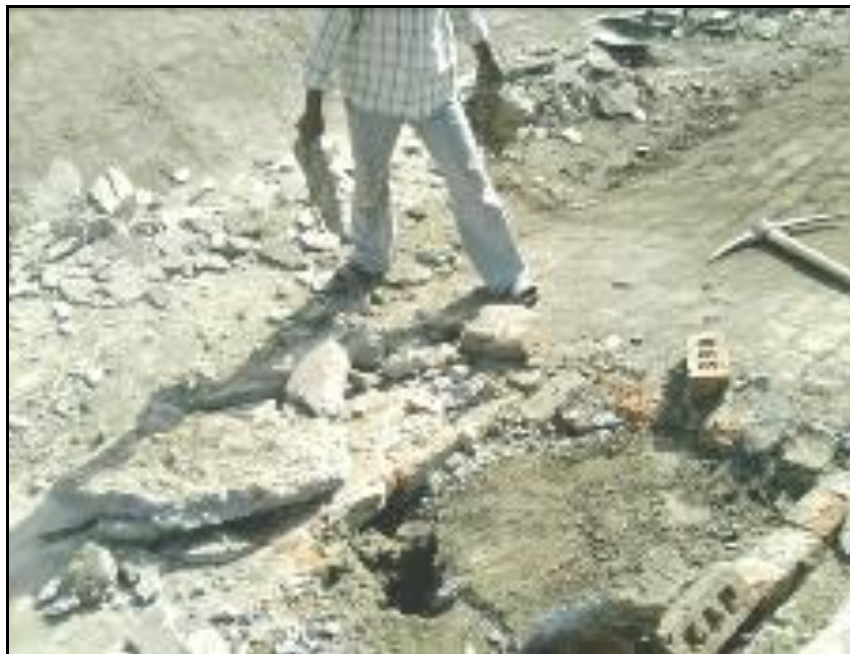
Photograph 14. Piping from sides of the canal

In the Tanchha Distributary, three patches (Ch 5.65 to 7.17 km, 7.17 to 7.92 km and 7.92 to 8.67 km) were identified where severe water seepage was observed. Since these three patches were adjacent to each other, they formed a continuous length of 3.02 km. This entire length of canal was required to be attended to urgently. Average perimeter of the canal section was 5.7 meters (m); bottom width was 1.1 m; inner slope of the canal was 1.5:1; outer slope was 2:1; full supply depth of the canal was 1 m; and the bed gradient was 1 in 6000 as per original design. The designed discharge, in the middle of the length of the canal was 1.51 m<sup>3</sup>/sec and was 0.76 m<sup>3</sup>/sec at the tail. The total command area of the distributary was a huge 2384 hectare. The said canal was constructed some 10 years back but unfortunately every season it was tried to be operated, it used to give more and more troubles in the form of various kinds of failures.

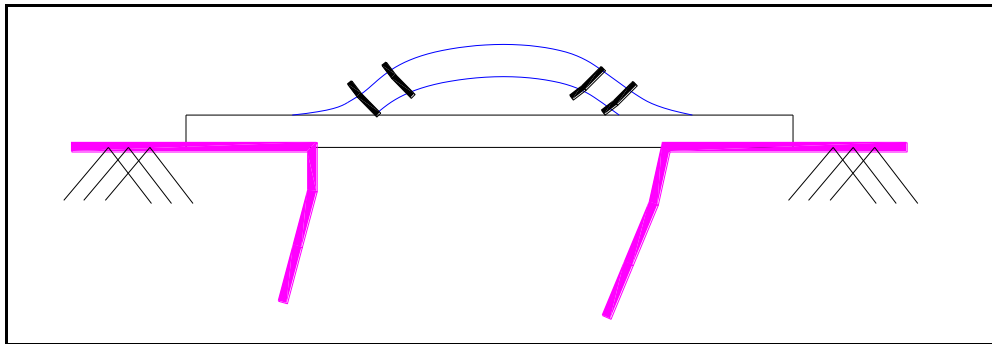
How canal embankments in swelling soil fail is interesting to understand. Soil of canal embankments made up of swelling soils tends to swell when comes in to contact of water. Because concrete or brick lining becomes saturated or some fine cracks give way to water, soil of embankment can not remain dry for a long time after commissioning of the canal. When the soil comes in contact of water, it swells. During the initial stage of swelling, hogging tendency in lining dominates and concrete or brick lining undergoes cracks as it has only little flexural and shear strength and then more water seeps through and further wetting the soil of embankment takes place. Then swelling aggravates gradually. It causes further upheaval of lining.

Figure 7. Hogging of lining due to swelling of soil

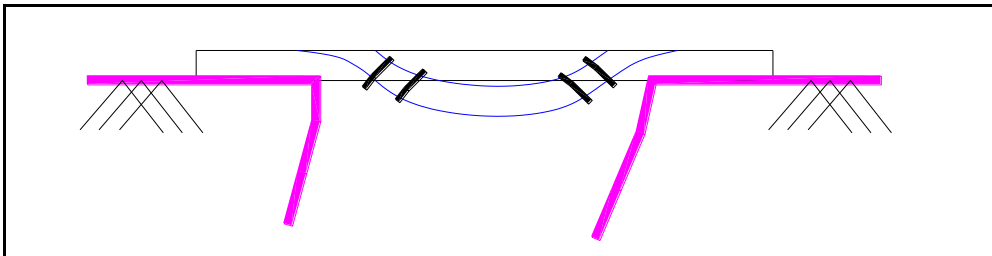
Figure 8. Sagging of lining under load of water mouth of piping

Moreover, at the entry point of piping which is really as hollow tubular way through the embankment as visibly shown in Figure 8, the lining behaves as if an unsupported slab under heavy load due to water and sagging occurs and the lining undergoes failure due to bending and shear. Brick lining is more vulnerable than concrete lining due to poor bending strength. This phenomenon finally forms a continuous pipe like mechanism within the embankment.

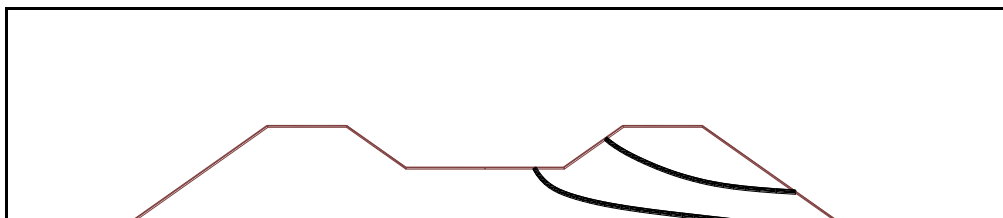
Figure 9. Paths of piping through embankment

When the canal is closed as per schedule, drying of the soil of the embankment results in to shrinking which causes wide cracks and gaps in the embankment. Subsequent operational phase of the canal, along with aggravating the swelling phenomenon, obviously signals piping as the passage to water through cracked lining and gaps in the embankment as well, is unobstructed and many such paths are created after some time in the embankment which not only saturate the embankment very soon but also raise the position of the phreatic line.

If the embankment does not have any internal drainage arrangement, raised phreatic line becomes a major reason for embankment failure. Heavy pore pressure in addition to several pipings make the embankment unstable and it becomes difficult to judge as to whether disintegration or dispersion of embankment under pore pressure first takes place or soil erosion through piping followed by crumble or subsidence happens prior to that or both the kinds of failures are mixed.

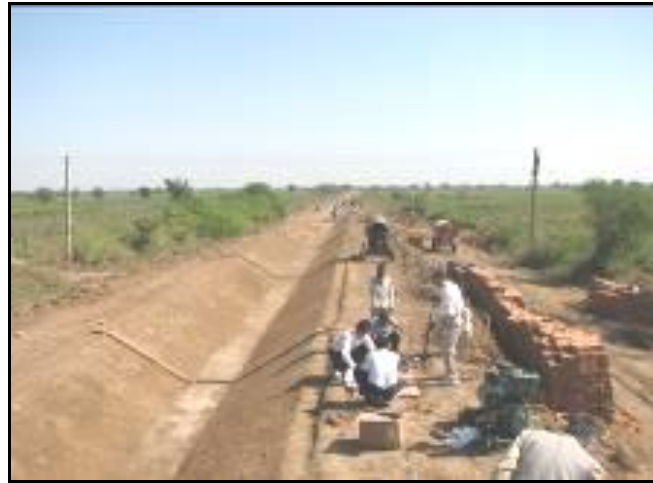
Photograph 15. Preparation of canal section

In the stretch in which the restoration was to be made, old brick lining was removed. As the bricks had already been separated due to failure of bonds under swelling pressure, the process of removal of lining was very simple. But the major problem was of the disturbed profile of the canal which was to be corrected to precisely meet the design. Prepared canal section is shown in Photograph 15. It required manual trimming or earth filling at different locations and re-leveling of the entire bed.

Then was required to fill up the visible pipings. Cement-mud grout 1:10 was used to fill up the visible pipings knowingly that the gravity grout could creep up to certain length only and not through the entire length of the piping as pressure grout could further damage an already weakened earthen embankment. Some invisible pipings or internal cracks could not be addressed. But here, there was clarity that strengthening of the embankment was not the objective, mouths of the pipings were to be sealed so as to reduce the number of bending mechanisms to be generated in the lining. However, the sealed mouths of pipings could not be expected to avoid bending mechanism

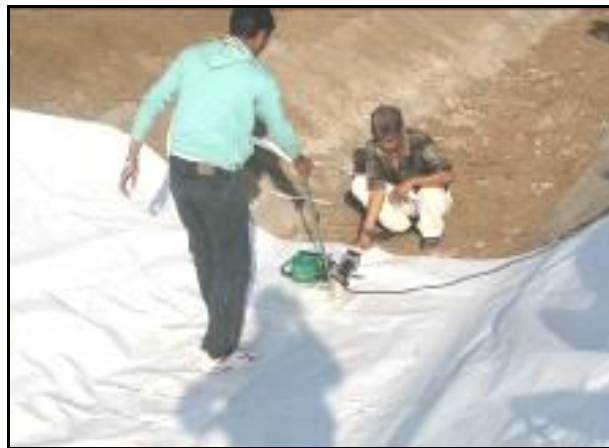
Photograph 16. Heat sealing of geomembrane

Rolls of 80 to 85 meter length were available for all the three materials. Heat sealing was required to be carried out on site. Machine parameters were optimized for this process. Different machines for heat sealing for different materials were used. Even the same machine can be used with different parameter settings for different materials. For all three materials, heat sealing on site was a rather simple and straightforward process.

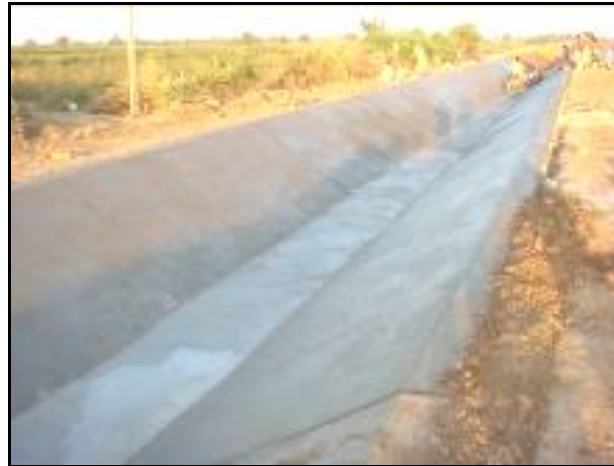
Photograph 17. Completed canal section

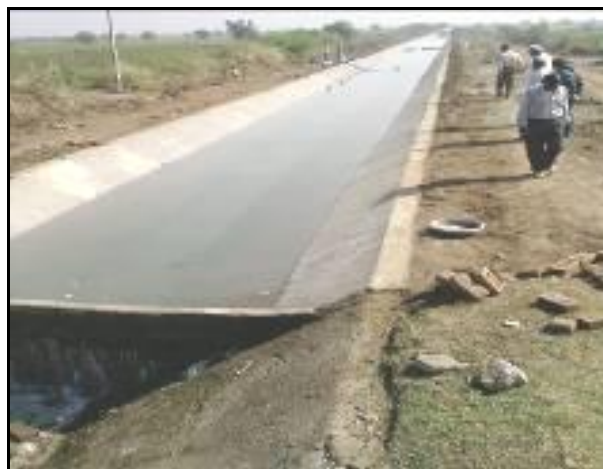
Photograph 18. Testing of completed canal section

For testing, there were two walls constructed in the canal to create a pool inside as shown in Photograph 18. This testing was carried out by filling water within the upstream and downstream walls and was done for a period of over 60 days.
