# Geosynthetics in irrigation canals in swelling soils of Gujarat, India : a case study

**ABSTRACT:** Because of several projects implemented in recent years as developmental activities, soil of good quality has been consumed on large scale. Irrigation canals need selective soils which are not available at present in many areas. If such soils are transported from long distance, the project becomes economically unviable. In such a situation, the soil of whatever type is available has to be used with due knowledge of issues related with and the solution as well. When heavy clay is the only option to be used for construction of irrigation canal, it swells or expands while in contact of water and shrinks while it dries. In such cases, as lining in the canal can not be impervious, the soil behind it is subjected to cyclical swelling and shrinkage. The result is failure of lining, pipings in the embankment, heavy leakages and even some time undulations in bottom such that the water can not flow at all. The paper discusses the issues of canals constructed with heavy soils, detailed diagnosis of the problems and specific solutions worked out using geosynthetics by referencing a few canals

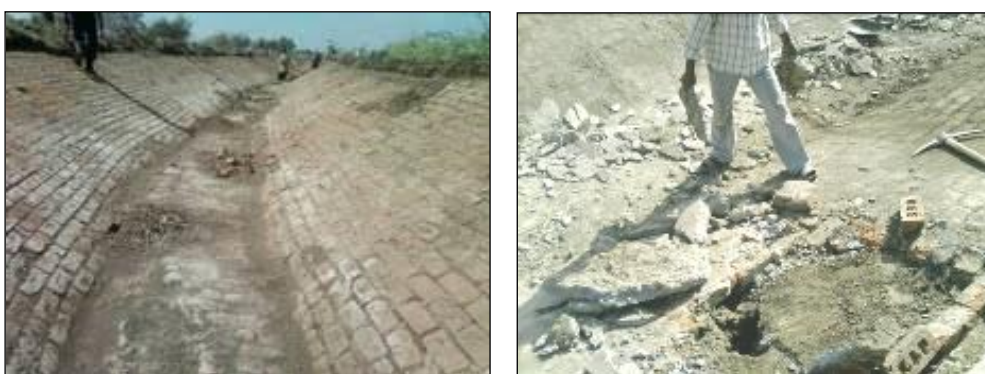
Photographs 1 and 2. Swelling of bed and sides and pipings from sides of Canal

The overall condition of the canal was very bad; the bed of the canal was highly uneven; the brick lining was significantly disturbed. This is schematically shown in Figure 5. The deteriorated condition of the canal was visible. The bed of the canal was also unusually swollen as shown in Photograph 1.

There were several other issues. The banks were disbursed. Canal section at one location was found to be much wider in comparison to what it was originally. The embankments had also been dislocated. At several locations, cracks and breaches were patched up by cement mortar or through plastering to restrict water seepage. The local farmers were forced to construct bunds on either sides of the canal to patch up the failure of the embankment. However, the canal embankment broke repeatedly and suddenly. Piping from canal banks i.e. sides of the canal as shown in Phtograph 2 and leakage from canal siphons, both, contributed to the seepage. These occurrences used to result in water inundation of the surrounding areas.

ment mortar as pointing. Then 18 to 20 mm thick single mala cement plaster was applied on top of the brick layer. The function of the cement plaster was to keep proper positioning of the bricks and as well as to provide a smooth surface. The inside surface of the canal was found smoother than the conventional brick lining. "Tanchha Distributary" was repaired this way as shown in Photographs 6 and 7.

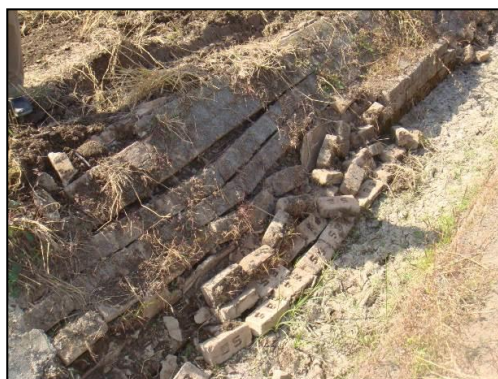
Photograph 3. Very high swelling and severe damage in Keshlu minor

Soon then in 2010 was found many such failures of many minor canals in the same district. One such minor was “Keshlu minor” meant to supply water to a village name by Keshlu of the same district. The damage in minors was found to be widespread and more severe as compared to bigger canals. As shown in Photograph 3, Keshlu minor was so badly distressed that the brick lining was completely disintegrated and the canal profile was badly disturbed and hence the canal had become defunct. This is an example to

give an idea as to how severe was the distress but many such canals were found. All the minors were 4 to 6 Kilometer long with designed discharge of 0.1 to 0.3 m<sup>3</sup>/ sec.

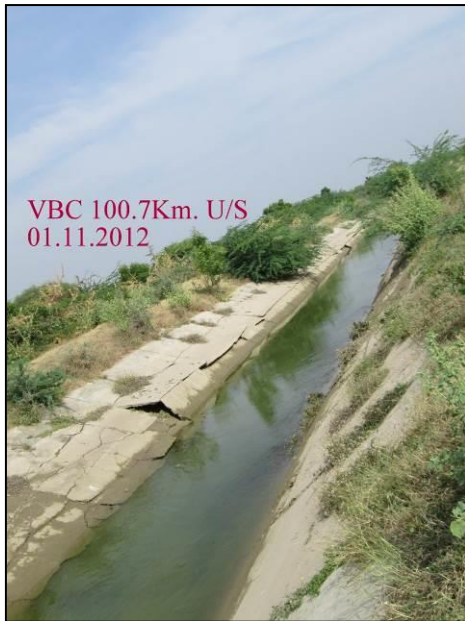
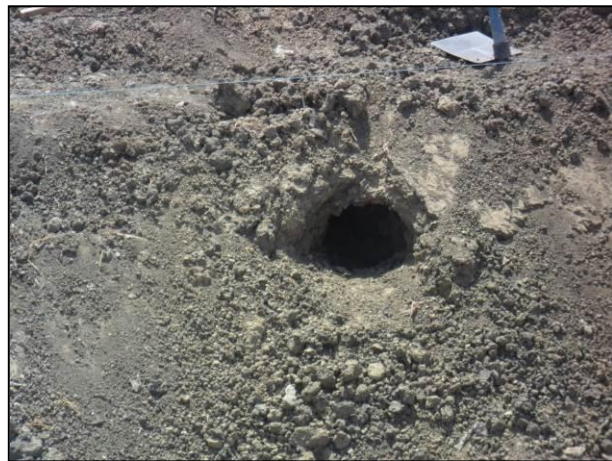
Photographs 4 and 5. Severe damage and pipings in the tail reach of Vadodara Branch Canal

A very big canal – Vadodara Branch Canal of the Sardar Sarovar Project was found to be very severely damaged due to swelling. It was 100 Kilometer long a canal with designed discharge of 76 m<sup>3</sup>/ sec. In the initial reach, the canal passes through intermediate clay (CI) type of soil and the embankments were also made up of the same soil and hence was no problem. But in the tail reach i.e. Chainage 105 Kilometer onward it was heavy clay and hence the swelling was very high. Concrete lining of 7.5 cm thickness was upheaved and broken in to pieces for a long stretch as shown in Photograph 4. Seepage through embankment was also very high and the canal was not flowing with full capacity. There were huge pipings behind the lining as shown in Photograph 5.
