Repairs of dam components subjected to dynamic loads with application of geosynthetics: case studies from India

ABSTRACT: Dam is a complex hydraulic structure having many components subjected to dynamic loads. Such components periodically manifest signs of distress and require repairs especially in case of aging dams. Conventional methods for repairs are mainly based on usage of impact resistant materials. As an alternative, solutions with geosynthetics are designed as impact resistant systems rather than depending merely on material properties. Such solutions not only help effectively repair the damaged components but also enhance their performance in several ways besides cost economy, faster execution and longevous life. The paper outlines main issues related to various dam components due to dynamic loads and presents case studies of aging Indian dams whose distressed components have been restored or are being restored with application of geosynthetics.

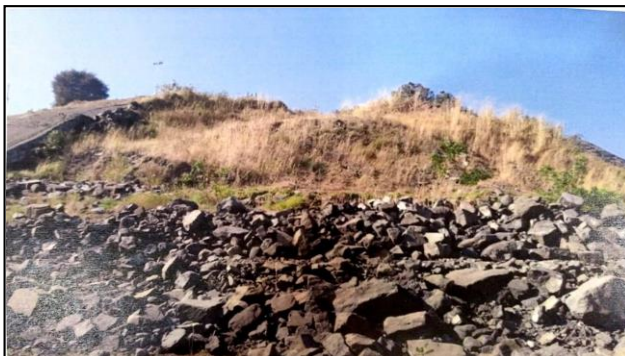
Divide bund acts as a groin on the spillway channel side, and, during the spillway operation, it is subjected to severe dynamic loads when it contracts the flow. Here, the original construction was in the form of an earthen bund covered with thick stone pitching. In spite of periodical repairs, signs of serious distress were observed in 2019. Near the hook-shaped nosing (Fig. 2), not only the stone pitching was disintegrated but also the stones were ruptured (Fig. 3) and the surface of the earthen bund was found badly eroded. Riverbed though made up of monolithic basalt rock was found eroded badly to the extent of 5 m in depth and 8 to 10 m in width. Heavy erosion in rocks may cause undesirable changes in hydraulic behavior of flow.

Figure 3. Distressed divide bund (Kapadia 2022)

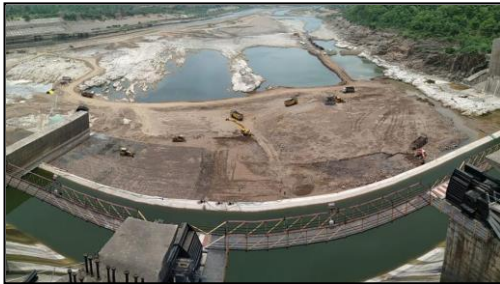
Figure 8. Execution of multistage secondary apron (Kapadia 2020)

Secondary apron was designed as a multilayer load dispersion system. The top layer of reinforced concrete slab, the middle one a composite layer of coarse aggregate and cement sand mix and the bottom as the biaxial geogrid with tensile strength of 30 kN/m to act as a separator cum basal reinforcement. This entire system was extended to cover the entire pit which was duly filled with graded rubbles. Conventional concrete apron resists impact mainly by its hardness. The solution designed here is a system that takes the impact with sharing its components amongst its members. Thickness of the reinforced concrete apron is required much less than in case of conventional solution because a part of the total impact is taken by it. This results in to a significant cost saving and should give better performance. This solution is in execution stage.
