# Geosynthetic reinforcement in distressed canal embankment in Gujarat, India : a case study

**Vivek P. Kapadia**

*Water Resources Department, Government of Gujarat, India (vivekpkapadia@gmail.com)*

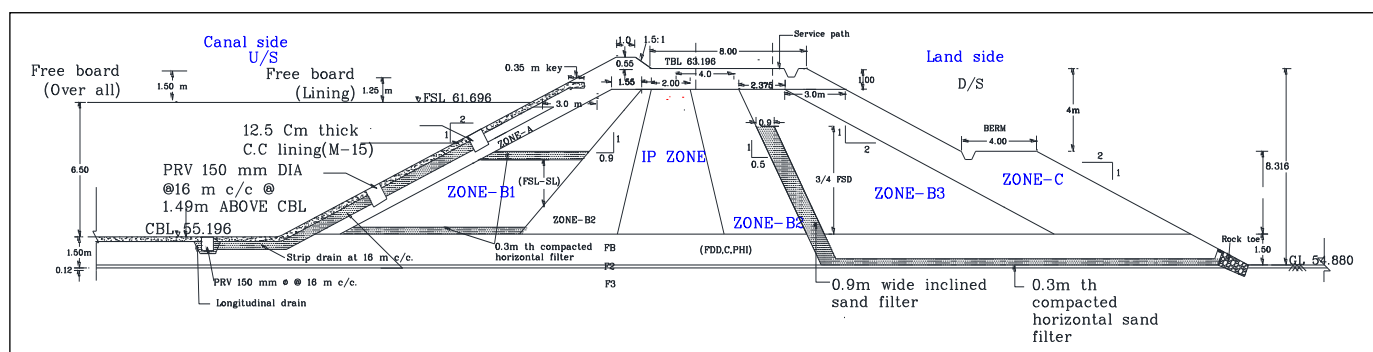
Figure 2. Designed section of canal embankment

The embankment design had been done according to the standard procedure laid down in IS-7894 (or IS 8826: 1978). For the stability of the canal side slope for the sudden draw-down condition, only 50% of the original undrained head of water has been considered for pore-pressures. This is on consideration that the lining is effectively impervious and that the horizontal filter blankets and the strip drains as well as Pressure Release Valves (PRVs) are adequately functional. As this is not the case now in most of the situations, because the lining gets damaged due to various reasons and allows leakage, it would be advisable to check the slope stability considering full 100% pore pressures in the sudden draw-down condition. Of course, the breach in the present case cannot be attributed to this aspect as the canal had been flowing only partially and no sudden draw-down condition had been created. Zoned embankment designed to suit the codal provisions, design practices and material availability is shown in Figure 2.

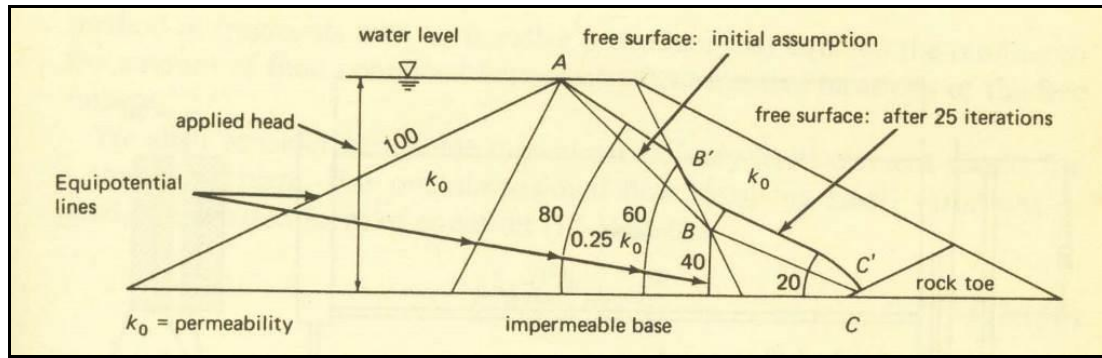
Figure 3. Steady unconfined seepage problem

The behaviour of the embankment narrated above was tried to be understood by Finite Element Analysis of the as built section. Properties were obtained during investigation as time was sufficient (failures started taking place in 2005) and size of the problem was large enough to find it worth to make detailed study and come to proper conclusions. Slip circle modelling can not be taken as a reliable way in a problem in which stratification of soil is there and variations in density and material are many and therefore Finite Element modelling as steady unconfined seepage type problem was done using four noded element in the self developed program. Steady unconfined seepage problem is shown in Figure 3. This type of problem is characterized by unique free surface, which does involve variations with time. The analysis suggested that the embankment with as built section property was unstable with the designed head in the canal. Continuous horizontal crack in the concrete lining was a sign of shear failure of concrete due to subsidence of soil mass behind it. Crumbling of soil behind the lining was due to presence of poorly compacted soil, which settled due to its own weight at certain depth within the embankment, which was observed during the investigation.

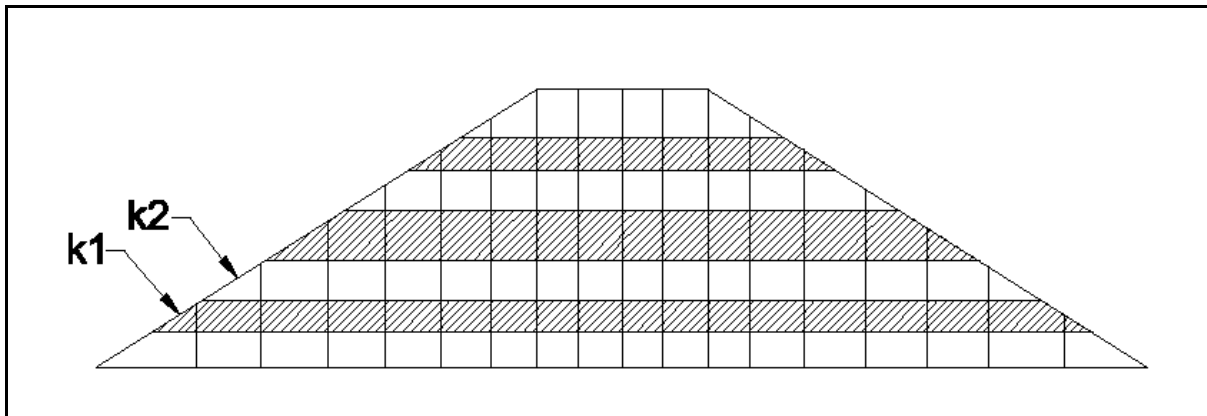
Figure 4 Conceptual modeling of stratified embankment

If there is zoned embankment, modelling as per Figure 3 is valid but in this case, there was no zoning but stratified layers were to be modelled and therefore conceptual mesh generation as shown in Figure 4 was followed. The actual mesh was much finer but conceptual basis with two different permeability values alternately varying vertically was adopted to go close to the reality.
