# APPLICATION OF GEOSYNTHETICS IN RESTORATION OF CANALS : CASE STUDIES OF SARDAR SAROVAR PROJECT

Vivek P. Kapadia, Chief Engineer, Water Resources Department, Government of Gujarat, Gandhinagar - 382010, India

## CASE STUDY – 1 RESTORATION OF BREACHED SECTION OF NARMADA MAIN CANAL

## CASE STUDY – 2 ADDRESSING FAILURE OF CANAL EMBANKMENTS IN SWELLING SOILS

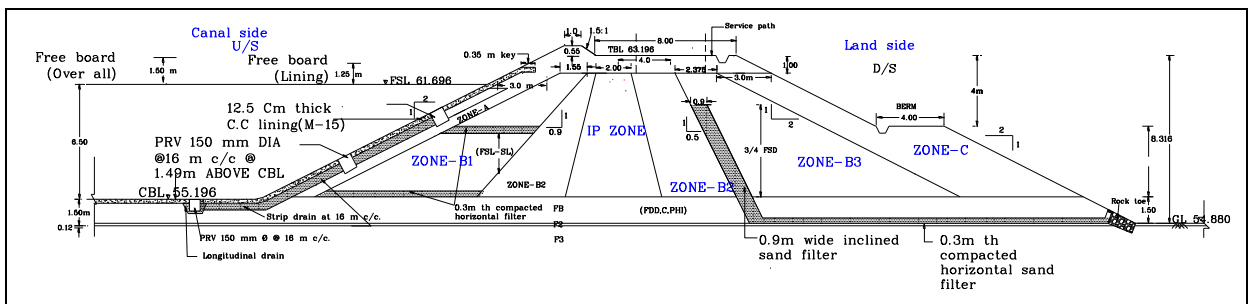
Figure 2. Designed section of canal embankment

The embankment design had been done according to the standard procedure laid down in IS-7894 (or IS 8826: 1978). For the stability of the canal side slope for the sudden draw-down condition, only 50% of the original undrained head of water has been considered for pore-pressures. This is on consideration that the lining is effectively impervious and that the horizontal filter blankets and the strip drains as well as Pressure Release Valves (PRVs) are adequately functional. As this is not the case now in most of the situations, because the lining gets damaged due to various reasons and allows leakage, it would be advisable to check the slope stability considering full 100% pore pressures in the sudden draw-down condition. Of course, the breach in the present case cannot be attributed to this aspect as the canal had been flowing only partially and no sudden draw-down condition had been created. Zoned embankment designed to suit the codal provisions, design practices and material availability is shown in Figure 2.

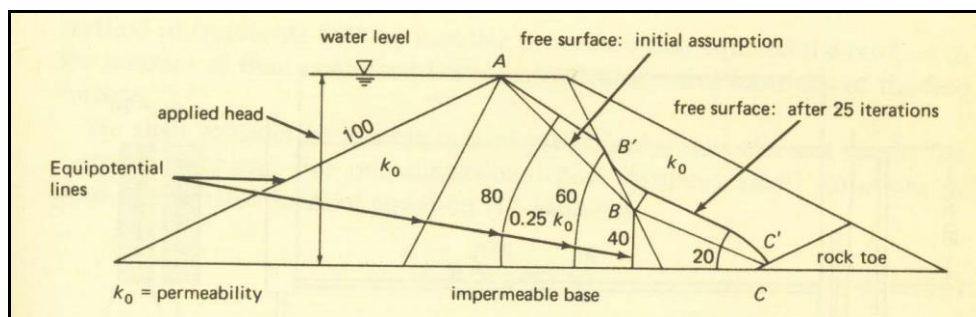
Figure 3. Steady unconfined seepage problem<sup>1</sup>

The behaviour of the embankment narrated above was tried to be understood by Finite Element Analysis of the as built section. Properties were obtained during investigation as time was sufficient (failures started taking place in 2005) and size of the problem was large enough to find it worth to make detailed study and come to proper conclusions. Slip circle modelling can not be taken as a reliable way in a problem in which stratification of soil is there and variations in density and material are many and therefore Finite Element modelling as steady unconfined seepage type problem<sup>1</sup> was done using four noded element in the self developed program. Steady unconfined seepage problem is shown in Figure 3. This type of problem is characterized by unique free surface which does involve variations with time. The analysis suggested that the embankment with as built section property was unstable with the designed head in the canal. However, this is possible when the lining failure is there which is due to crumbling of poorly compacted material due to its own weight at certain depth within embankment itself. And exactly this was observed during the investigation.

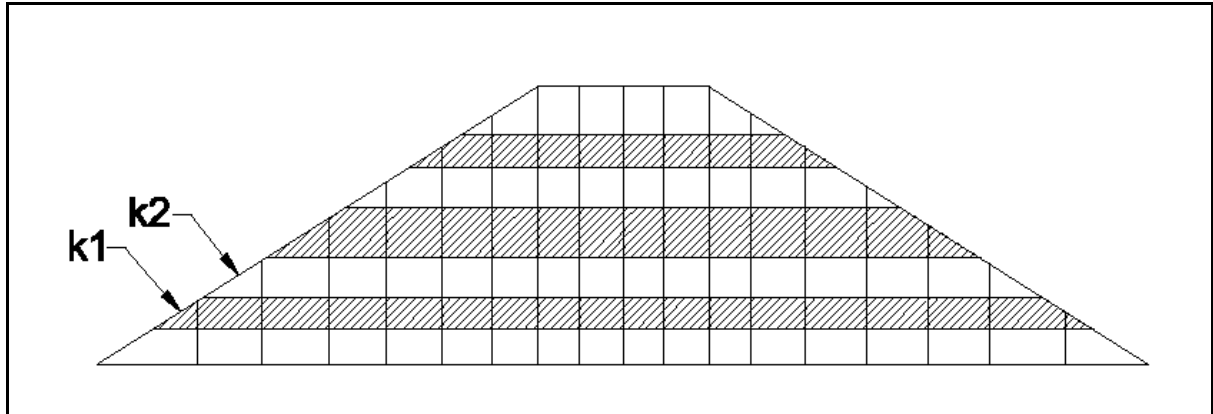
Figure 4 Conceptual modeling of stratified embankment

If there is zoned embankment, modelling as per Figure 3 is valid but in this case, there was no zoning but stratified layers were to be modelled and therefore conceptual mesh generation as shown in Figure 4 was followed. The actual mesh was much finer but conceptual basis with two different permeability values alternately varying vertically was adopted to go close to the reality.

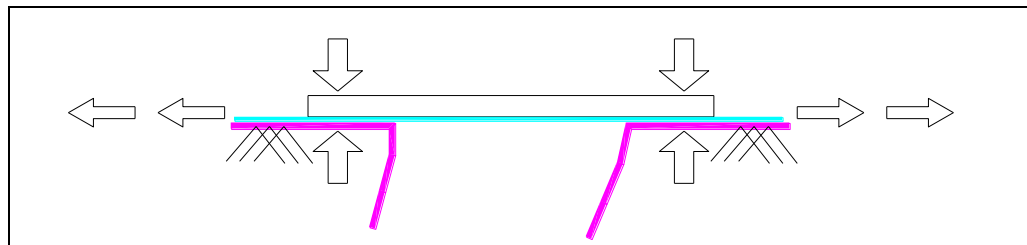
Figure 13. Bending of slab converted to tension in geomembrane

But in the existing canal in swelling soil wherein there are many piping paths in the embankment all of which are not visible during restoration, the role of geomembrane can not be limited to check the seepage. During swelling, hogging of lining takes place at the mouth of the piping and during shrinkage, sagging. The geomembrane is gripped all around the mouth of the piping under the load of the lining and water also and hence the uniformly distributed load occurred by swelling or shrinkage (due to residual water content) of soil beneath is taken by it in the form of tension which relieves the slab from bending. Thus, tension mechanism replaces bending mechanism due to geomembrane. Therefore, geomembrane should possess sufficient tensile strength. Moreover, cropping of weed from the soil would tend to puncture the geomembrane and hence it should possess sufficient puncture resistance. The most critical aspect is that, failure of geomembrane in any case either by tension or by puncture or by failure of joinery would give way to all the problems related to swelling and shrinkage and the entire solution worked out would be almost of no use. Therefore, right choice of geomembrane and workmanship as per site situation becomes very important.

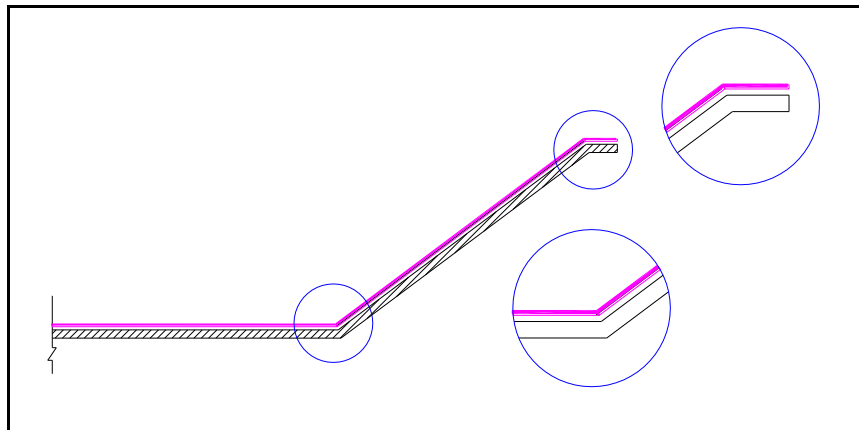
Figure 14. Handling aspect - bending ease of geomembrane (Preferred)

Placing of geomembrane in position in canal section proved that bending ease i.e. ease in folding of geomembrane was an important criterion. Figure 14 and Figure 15 illustrate this phenomenon geometrically.

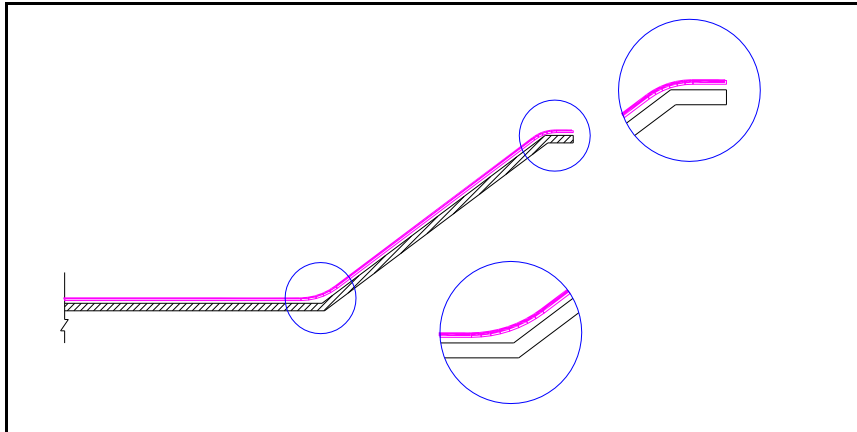
Figure 15. Handling aspect - bending ease of geomembrane (Not Preferred)

The geomembrane should be closely touching the sub-base so that there is no hollow between the geomembrane and the sub-base. On the flat surface this could be achieved without significant difficulties. Undulations and edges of the canal section put challenges against placing of geomembrane. At the edges of the canal section, there were two possibilities – formation of proper corners in geomembrane or formation of curved surfaces near the corner edges. The polyolefin could be bent easily and was found to be extremely good for bending ease. With HDPE, the experience was totally opposite. It was very difficult to place the HDPE in the canal as it made a chamfered surface at all the edges and corners in the bed as well as within the key of the canal. LDPE was largely unsuitable for this purpose.

Where the geomembrane was properly placed on the sub-base, brick lining was not difficult as the surface of geomembrane did not have any play. The placement of brick lining over the geomembrane at the edges as well as the corners became a major difficulty where the geomembrane was rigid against folding which happened in the case of HDPE and LDPE. Rigid material was found to have created hinge like motion and the bricks tended to be displaced. For small canals, this limitation of HDPE in bending could be further amplified, since the respective edges and corners would be extremely close to each other.
